Pipe Casing Injection for Corrosion Protection of Pipeline Carrying Carbon Dioxide

Project Specifics

Installation Dates
June 15, 2020

Location
Texas, USA

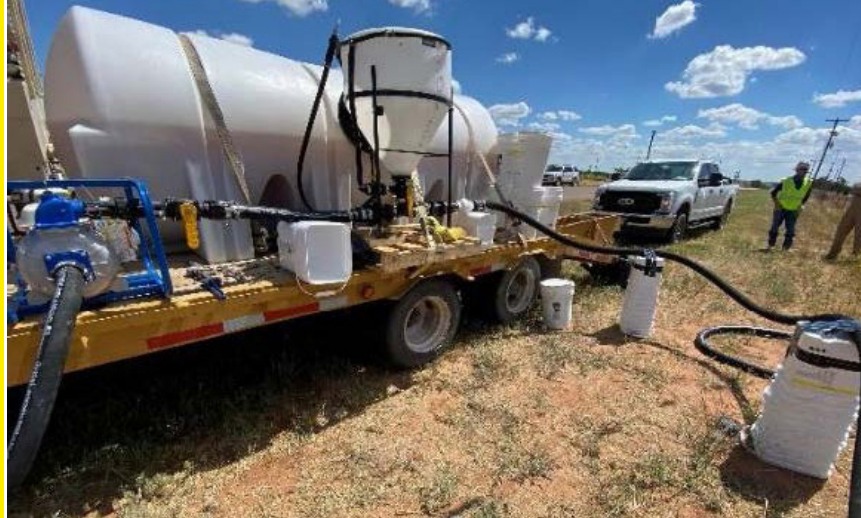
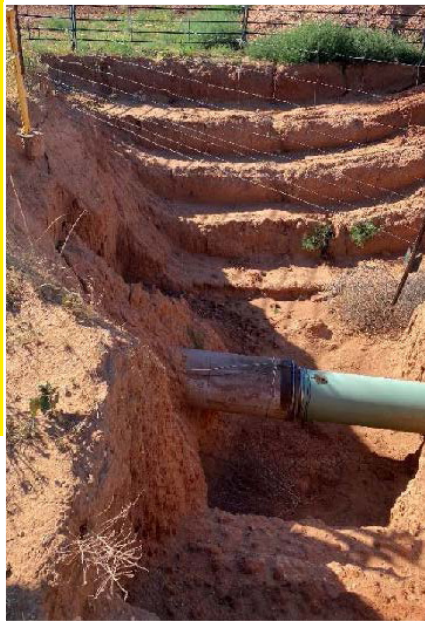
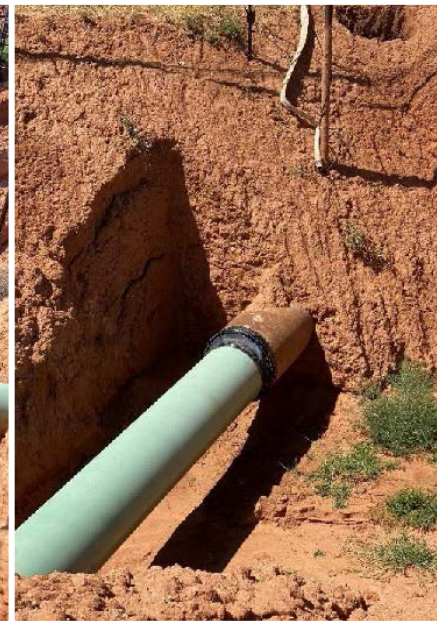
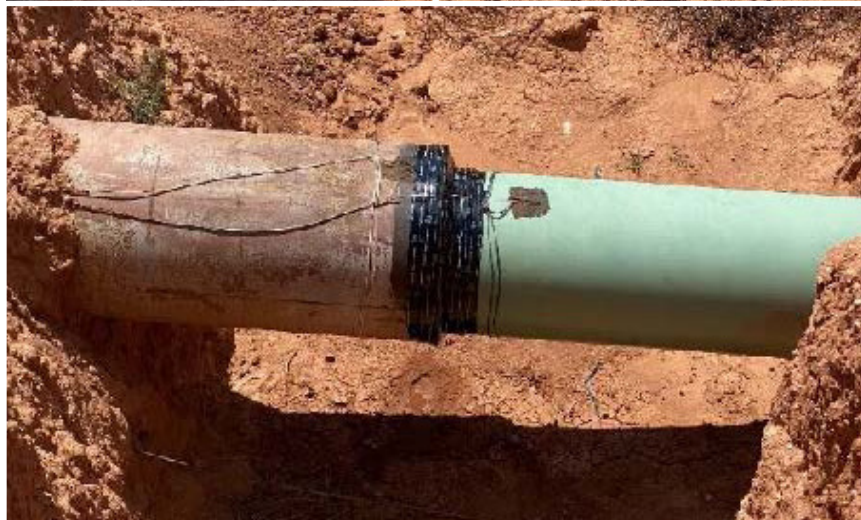
There is a slight decline going away from the aqueduct. Both vent pipes were located on the top of the casing. It should be noted that in January of 2020, prior to the injection, the end seals were refitted with new rubber seal gaskets. These excavated ends were not back filled and not covered.

The rubber seals were inspected and some drying and cracking noticed. Additional rubberized sealing tape was sourced locally and applied over the rubber gaskets on both ends of the casing.

The 3" vent pipe used for the injection had to be cut and fitted with 2" reducer and banjo type connector. Same 3"x2" rubber coupler was used to replace the cut section of the vent pipe to restore the "candy cane" like shape. The other vent pipe also needed a rubber coupler. The injection went well. PGH-300 and PGH-400 was added to the inhibitor slurry during the injection. A person stood watch over the opposite side of the casing to see if there was any discharge. None was reported.
