Corrosion Protection for 2 Double Bottom, Out-of-Service Storage Tanks, on Sand Foundation by Underside Injection IDS

Project Specifics

Installation Dates
July 7-8, 2020

Location
North Carolina, USA

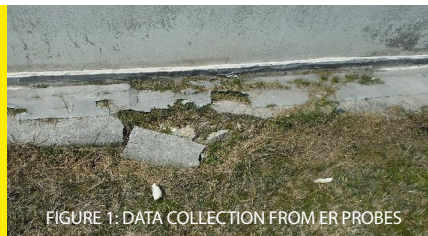
FIGURE 1: DATA COLLECTION FROM ER PROBES

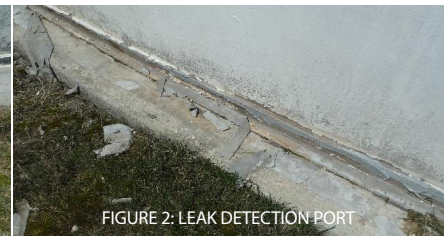
FIGURE 2: LEAK DETECTION PORT

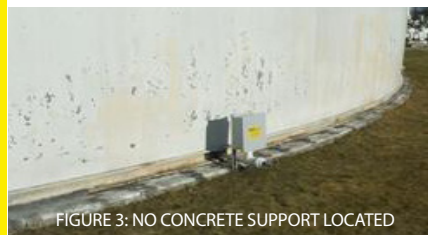
FIGURE 3: NO CONCRETE SUPPORT LOCATED

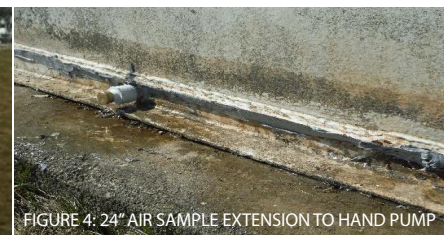
FIGURE 4: 24" AIR SAMPLE EXTENSION TO HAND PUMP

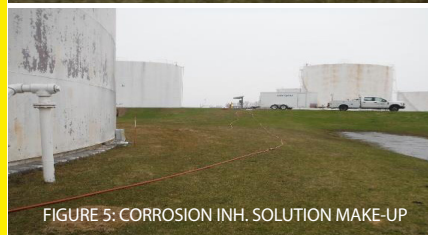
FIGURE 5: CORROSION INH. SOLUTION MAKE-UP

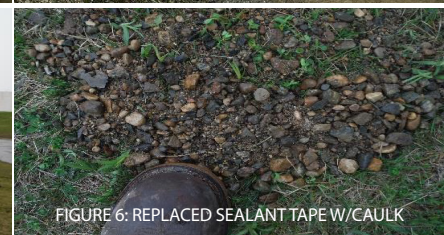
FIGURE 6: REPLACED SEALANT TAPE W/CAULK

All previously installed ER probes were in very good condition. No new ER probes or containment was necessary. All existing injection ports were in good condition. No additional pipes or fittings were necessary. Sealant tape from previous work consisted of six small (24" or less) sections along the underside of the newer chime. Two (2) portions were replaced with Sikaflex-221 but the others appeared to be holding firm. All of the provided Zerion FVS solution was injected without incident and only two (2) small leaks were observed, losing a total of 1-gallon or less. Leaks appeared to be the result of poor weld quality as the bead on the underside of the second (newer) chime was very inconsistent. Injection proceeded through all four (4) ports equally and was completed in one hour.

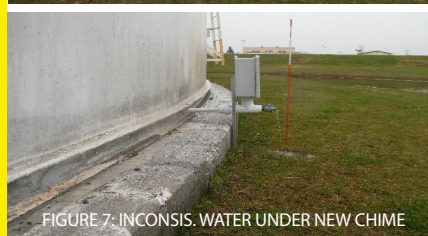
FIGURE 7: INCONSIS. WATER UNDER NEW CHIME

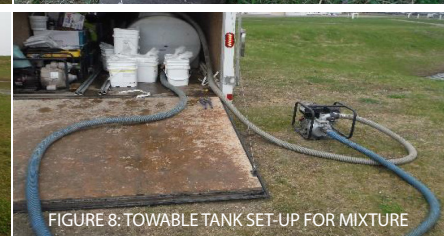
FIGURE 8: TOWABLE TANK SET-UP FOR MIXTURE
