Corrosion Protection for an Under Repair Out-of-Service Storage Tank by Drip Tube and Underside Injection IDS

Location
Texas, USA

Asset Details
Diameter: 110 Feet
Storage Product: Not Available
Vessel Construction: Out-of-Service (Under Repair)
Foundation Media: New Sand to be Installed

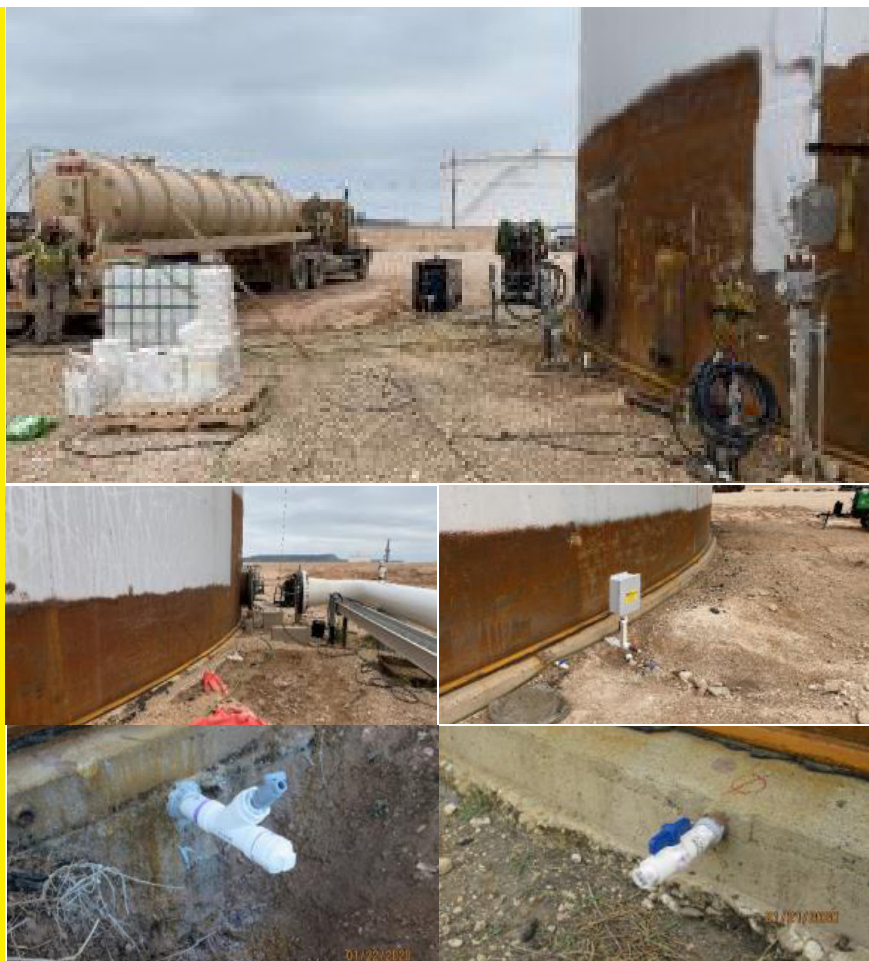
Zerion® FVS Corrosion Inhibitor Powder solution was applied. Provided and installed 2" diameter micro slotted PVC pipes and sleeves that cross in the middle of the tank and then come out of the ring wall. The 2" pipes arrived in 20 ft sections and installed with a 4-way connector. Solid 2" PVC pipes were installed through the ring wall and liner; sealed and then continued with the slotted pipes under the tank in the sand foundation (sand to be installed after CP work is completed). The Y-type connectors were fitted on each end of the pipes to allow installation of Stealth copper sulfide reference electrode and corrosion inhibitor slurry. There are (32) original steel pipes noted installed into concrete about 2" below old floor. (5) steel pipes were rimmed out to allow installation of 1/2" PVC pipes equipped with shut-off valves. The pipes were extended through the ring wall and liner; sealed and then continued about 10 feet into the sand. These ports could be used as leak monitoring ports or for VCI replenishment.

Everything went well and all parties were satisfied. A slight slurry leak was noticed between the tank floor and the concrete ring wall during the VCI injection. Estimated 20-25 gallons of slurry was lost. A complete chime seal installation is recommended to prevent the ingress of the water/contaminants and to extend the life of inhibitor.
