# Corrosion Protection of Casing for a 240' Length Pipe using Zerust's Zerion® FVS Powder, & PGH-300 & 400 Gels

## Project Specifics

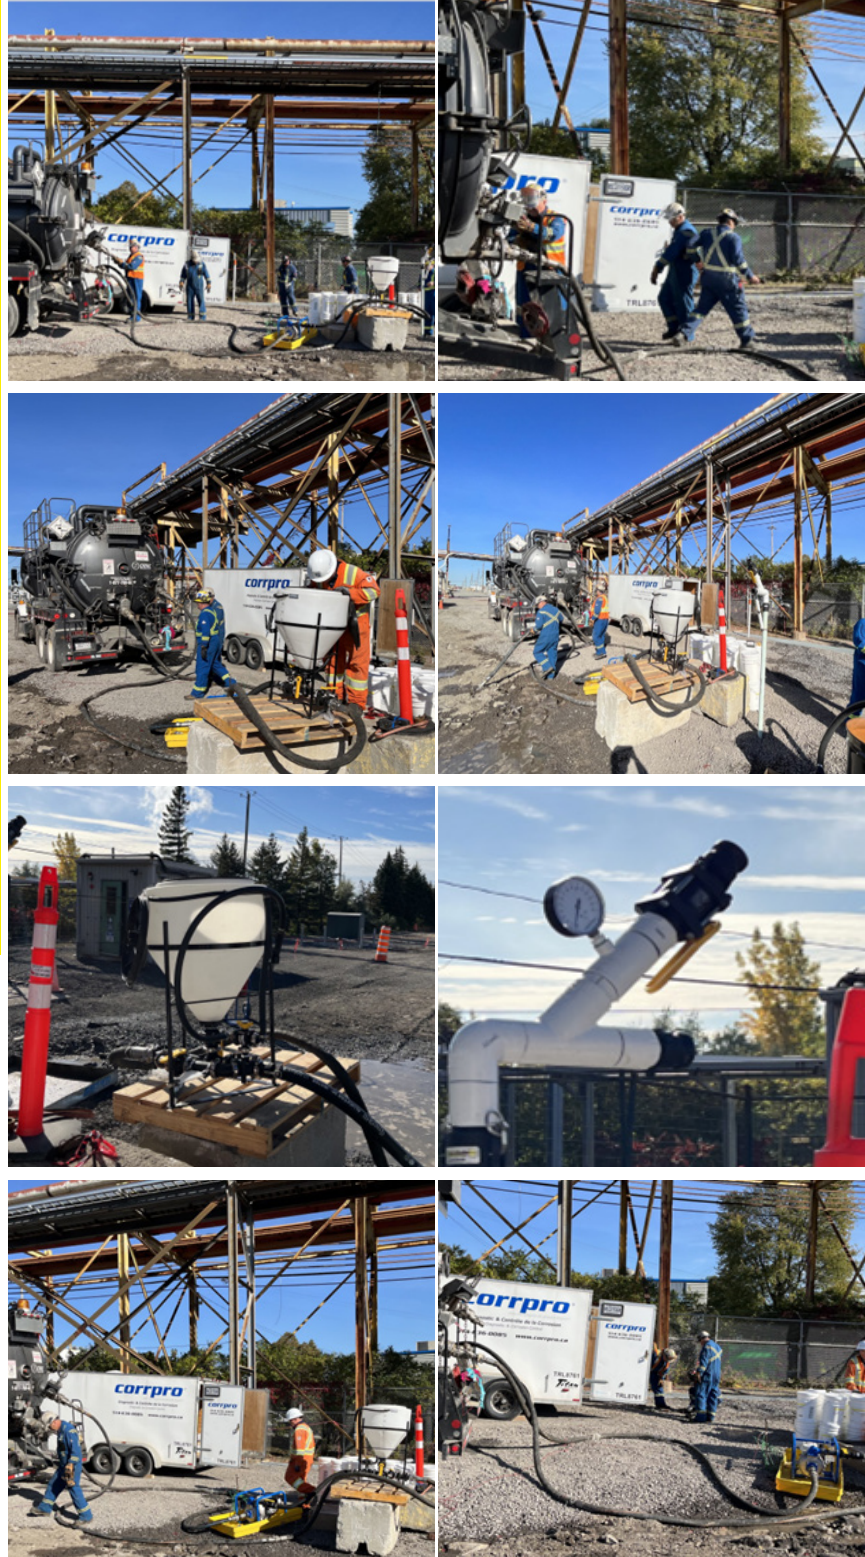
The pressure level was monitored during injection and stopped once liquid egress was noticed from the opposite vent pipe. In total, about 27 pails (405-kg) of Zerion FVS corrosion inhibitor, 15 pails (80-kg) of Zerion PGH-300, and 14 pails (80-kg) of Zerion PGH-400 were mixed with 1,300-gal of water and injected into the casing; it was assumed that 700-gal of water was present in the casing before injection, and the total volume of the final solution inside the casing totaled up to 2,020-gal.
