Protection of Natural Gas Pipeline

Pipe Casing Injection

Zerust® Oil & Gas was awarded a project encompassing the injection of three pipe casings all located beneath roads and highways.

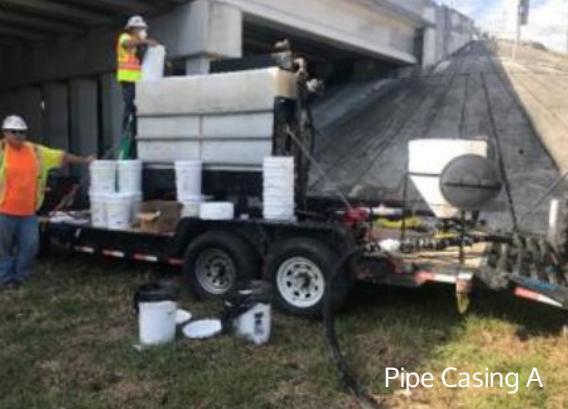
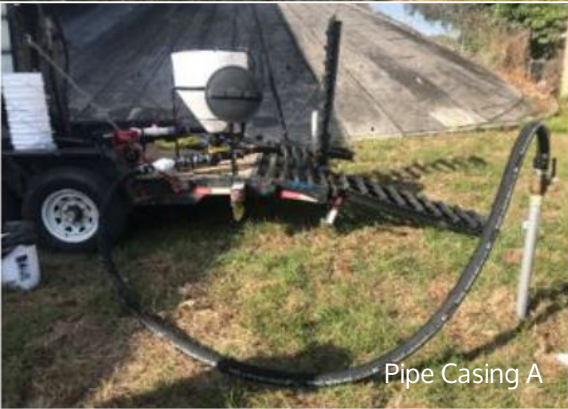
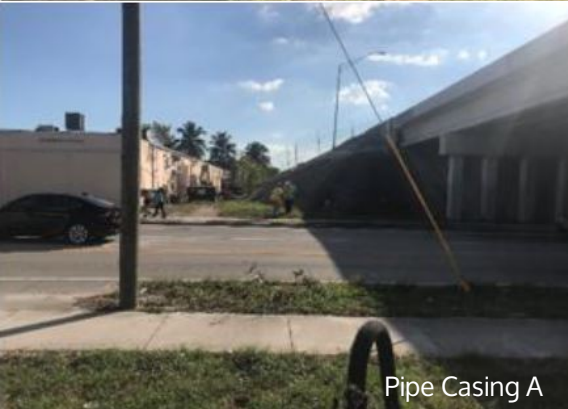
Pipe Casing A

Pipe Casing "A": Premixed all FVS and PGH-300 Gel into mixing tank and circulated pump to ensuring proper mixing. Some water was present inside casing and blew out the opposite end vent pipe during the injection. The pump was shut down at that time. ~5 gallons blew out the opposite end of casing that resulted in about 20 gallons left inside the mixing tank. Assumed the casing had ~5% of water present prior to injection.

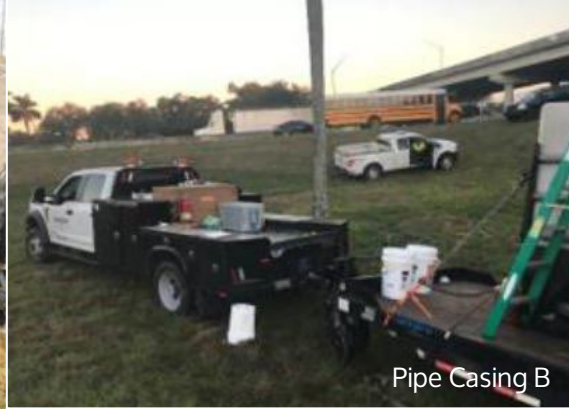
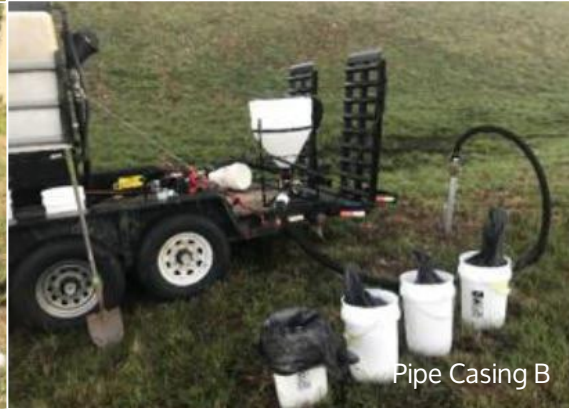
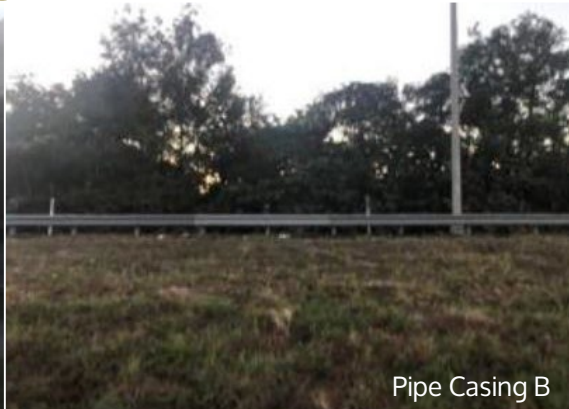
Pipe Casing B

Pipe Casing "B": Premixed 8 pails of FVS (8/10) and 2 pails of PGH-300 Gel (2/4). Water started to blowout the opposite end after 2 minutes, but was deemed acceptable by the client on site. Due to the approx. 90% water found inside the casing, the remaining 2 pails of FVS and all the PGH-400 (4 pails) was injected into the casing. Only 2 pails of PGH-300 was remaining due to the overfill of gel from opposite end.

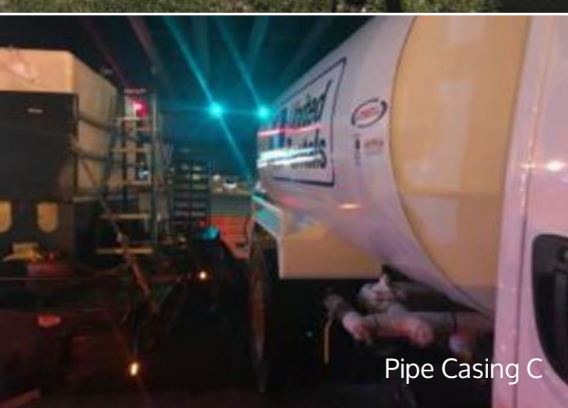
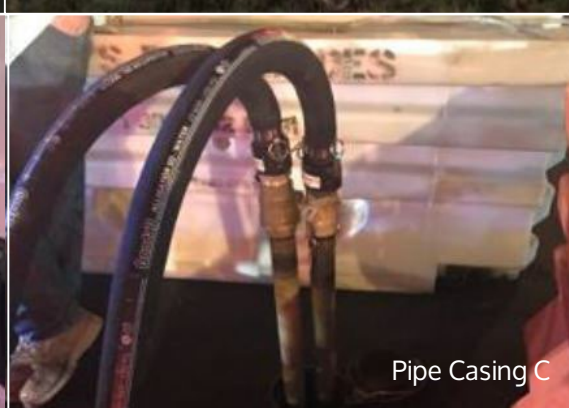
Pipe Casing C

Pipe Casing "C": This casing had 2 vents at the same end, with one vent on the side and the other on the top of the casing. Injection through the side vent with a separate hose leaving the top vent and positioned back into the mixing tank, incase of overfill/etc. Three (3) pails of PGH-300 and 7 pails of FVS added into mixing tank and allowed to circulate with ~450 gallons of water. The remaining material (4 pails PGH-400, 2 pails FVS, and 1 pail PGH-300) was added into the hopper during injection. All shipped material was injected into casing.
