Corrosion Protection for an Out-of-Service Petroleum Storage Tank on Concrete Foundation by Underside Injection

Underside Injection IDS with Corrosion Monitoring Coupons

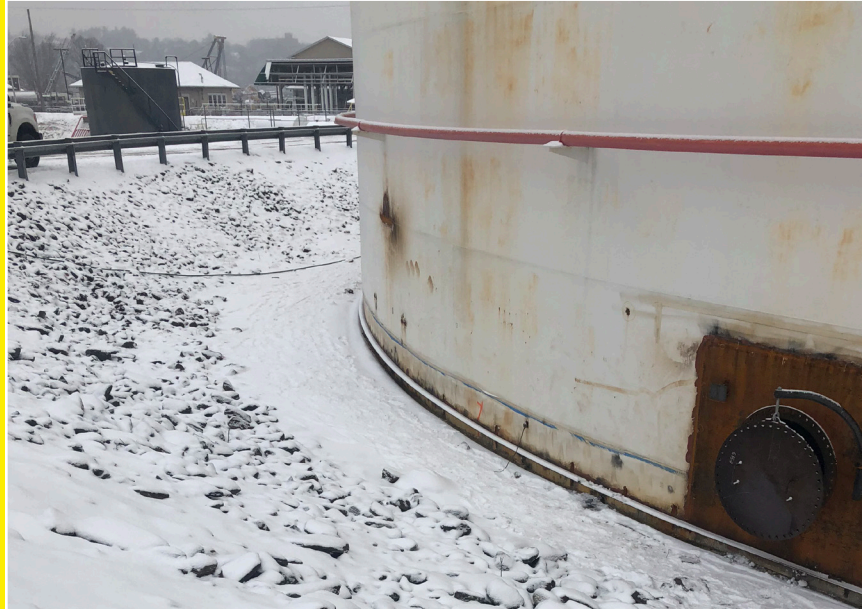
There were nine ports available for injection. Two of the ports were in immediate proximity with each other. It was decided not to inject into both. Thus, only eight ports were used for injection. This is illustrated in the figure below. The double bottom tank have been sufficiently welded not to allow for leaks. The area was monitored for other leaks, and none were found. Each port was injected independently, and each received 100 gallons.
