## Pipe Casing Injection for Corrosion Protection of Petroleum Pipeline **Pipe A**

## Pipe Casing Injection for Corrosion Protection of Petroleum Pipeline **Pipe B**

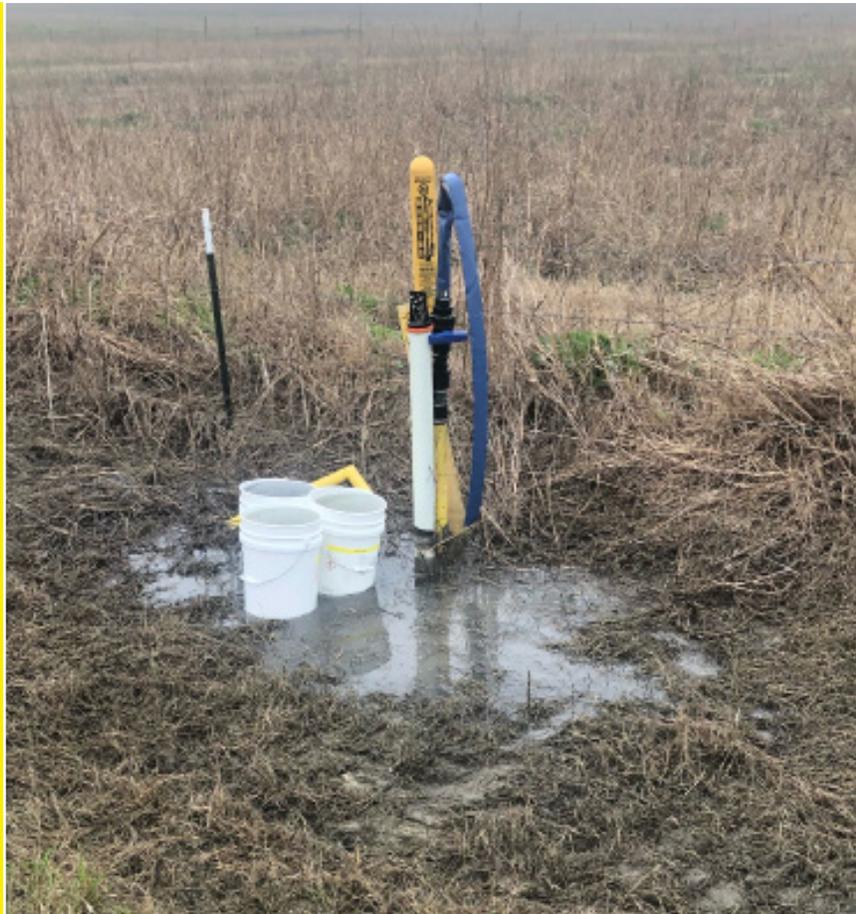
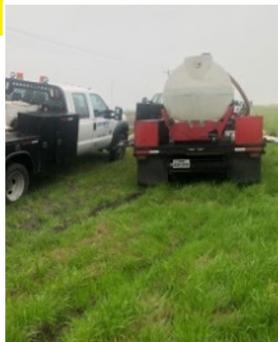
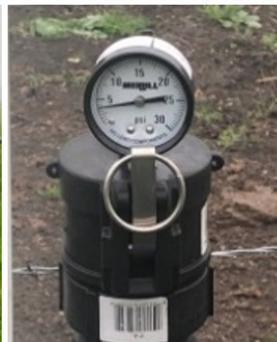
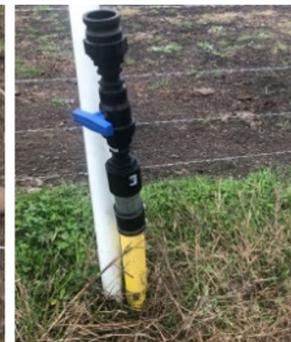
It was decided to use both the mud mixing pump and the 3-inch pump in tandem to create enough pumping pressure to generate a fast enough flow to produce a vacuum through the hopper. The mud mixing pump would pull the slurry out of the tank, and the trash pump would pull the slurry out of the hopper and push it into the casing. Even with the weight of the slurry, and the weight of the water in the casing, those two pumps gave enough pressure to create a vacuum in that hopper.

The issue now was that the hose clamps on the boot weren't strong enough. Because of the back pressure, we probably shot that vent/hose attachment off the vent about 5-7 times. In the end two additional hose clamps were added to hold the hose attachment to the casing. The entire volume of slurry in the tank was pumped, but only three pails of PGH-400 gel was added through the hopper. The installation was successfully completed.

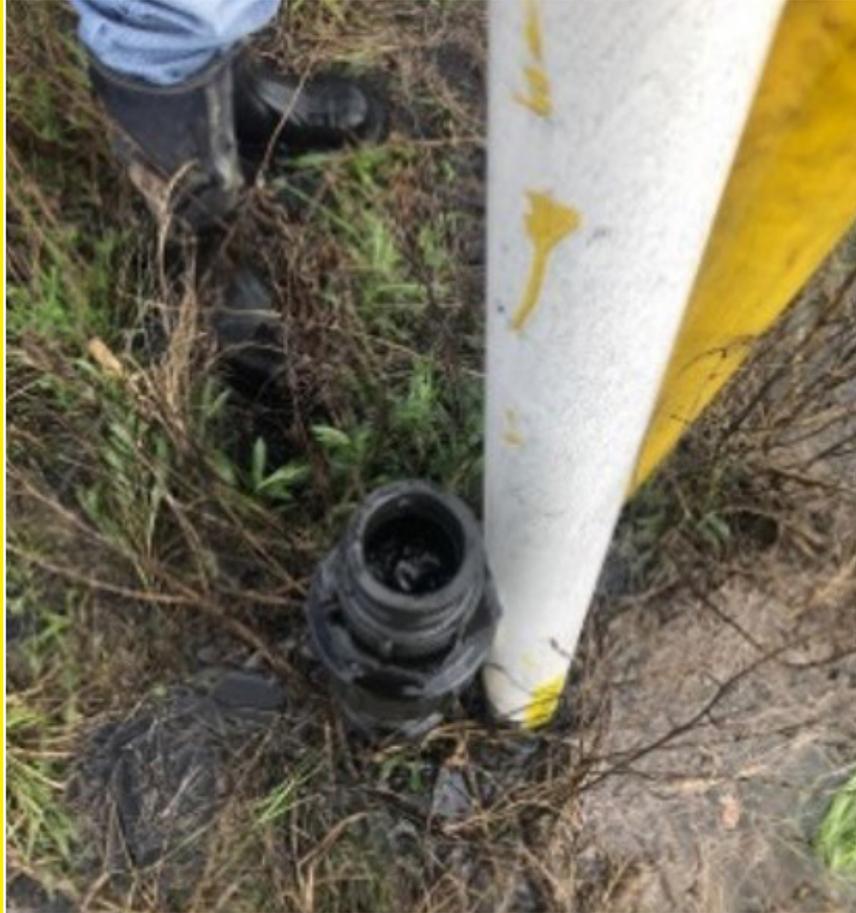
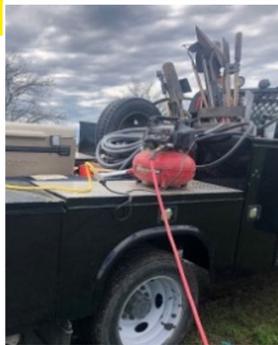
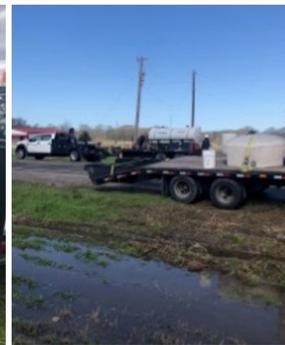
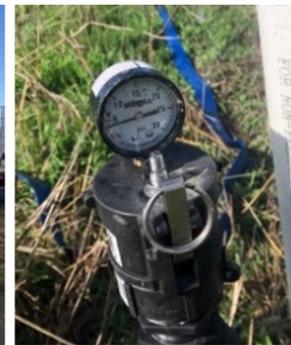
An air compressor was used to conduct a pressure test. It was able to hold 3.5 psi. The assumption was that 5 psi was not reachable due to the amount of water in the casing. The client's representatives were fine with continuing the injection, nevertheless.

Because of the large amount of water in the casing, backpressure was generated during the injection. There was not enough pressure from the pump to be able to use the hopper. Four pails of PGH-300 gel had been added to the tank, and an additional 1.5 pails of PGH-400 was also added since it could not be added through the hopper. An additional 200 gallons of water was added to the tank to allow for the additional gel to be pumpable.

After 50% of the tank had been pumped, the mud mixing pump could not produce enough pressure to push the slurry. We were able to connect the 3-inch trash pump to the back of the tank. This trash pump proved to be capable of pumping in the remaining gel. The installation was successfully completed.
