Corrosion Protection for an Out-of-Service Diesel Storage Tank on Concrete Foundation by Underside Injection and Dry Tube IDS

Details
Vessel Diameters: 52 Feet
Storage Product: Diesel
Vessel Construction: Out-of-Service, (4) Leak Detection Ports, (18) VCI Trench Ports
Foundation Details: Concrete, 2' Deep with Cone-Down Slope
Inhibitor Delivery System (IDS)
Underside Injection and Dry Tube IDS

Zerust Product(s) Used
Zerion® FVS Corrosion Inhibitor Powder
Zerion® FVS-S10 Corrosion Inhibitor Sleeves
ER Probe Monitoring and Corrosion Monitoring Coupons

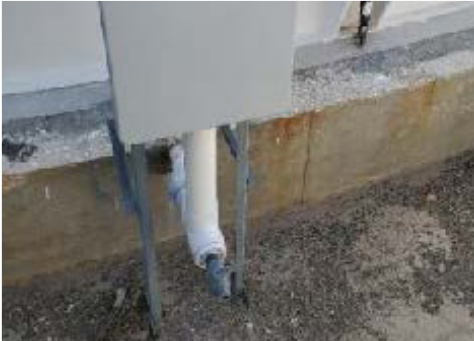
1. INSTALLED ER PROBE WITH ENCLOSURE

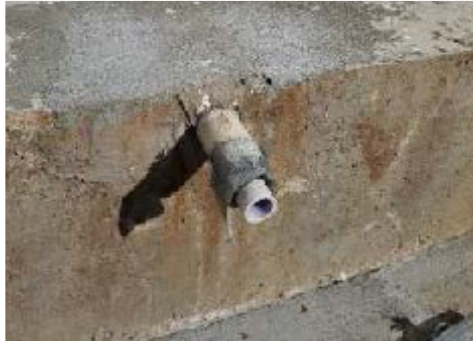
2. PREVIOUSLY INSTALLED COUPON PORT

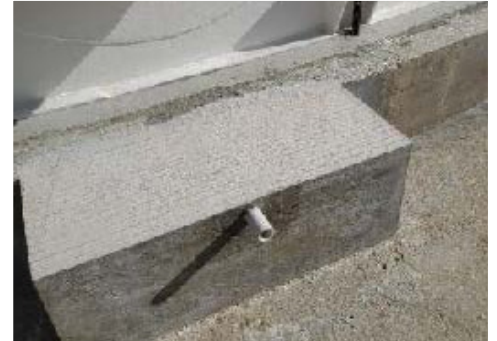
3. TRENCH VCI PORT

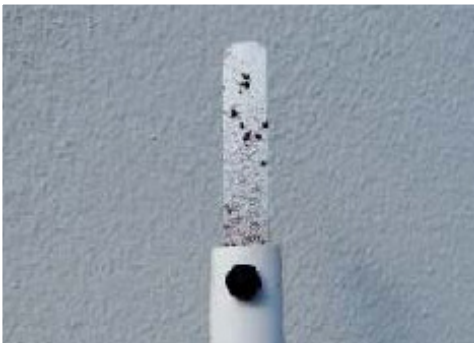
4. PREVIOUSLY INSTALLED. COUPON

Finally, on the third day of the site visit a local maintenance team was trained on how to take ER probe readings and how to replace the corrosion inhibitor coupons. New coupon assemblies were installed in the trenches originally installed with coupons. Previously installed corrosion monitoring coupons were taken back to the Zerust Oil & Gas office in Beachwood, OH for analysis.

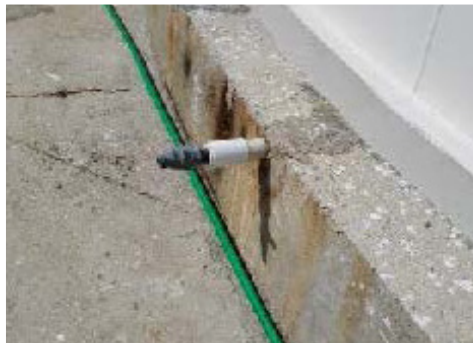
5. INSTALLATION OF INJECTION BALL VALVES

On the first day of this site visit inventory was taken of all materials, the previously supplied ER probe data was verified in working condition and ER probe readings were recorded from units previously installed. Previously installed corrosion monitoring coupons were removed. Each port pipe was fitted with PVC ball valves to allow for an injection of corrosion inhibitor slurry. These valves were not permanently adhered so that they could be removed and replaced with caps on the second day. No issues or problems occurred during the slurry injection. The Leak Detection port at 30° was opened post slurry injection and it was noted that corrosion inhibitor slurry did come out, indicating full coverage beneath the tank with the solution.

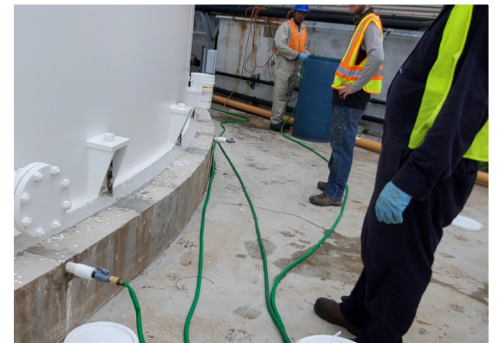
6. VCI SLURRY INJECTION

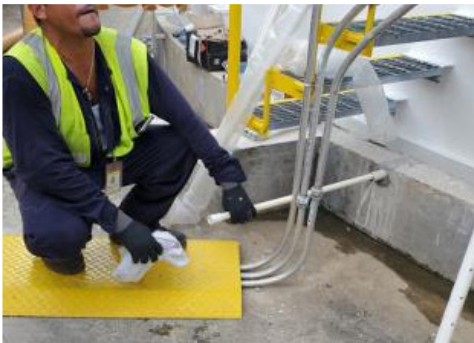
7. INSTALLATION OF PIPES WITH VCI SLEEVES

On the second day of this site visit each port (aside from those fitted with ER probes and coupons) was measured for a total length and then fitted with PVC perforated pipes with corrosion inhibitor sleeves. These were duct taped as it was found during installation that the provided end caps would not fit in the trenches. Every trench pipe was fitted with a threaded PVC cap to close the system and grout and polyurethane was reapplied around the chime as needed. Each port was labeled with Zerust Oil & Gas VCI system labels and monitoring equipment labels accordingly.

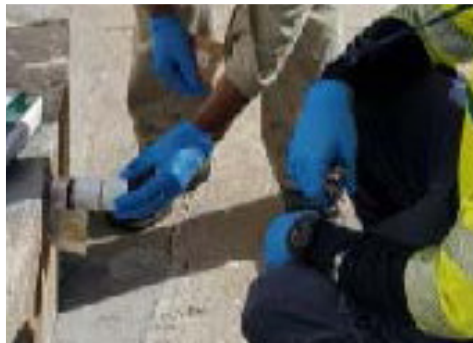
8. COUPON REPLACEMENT

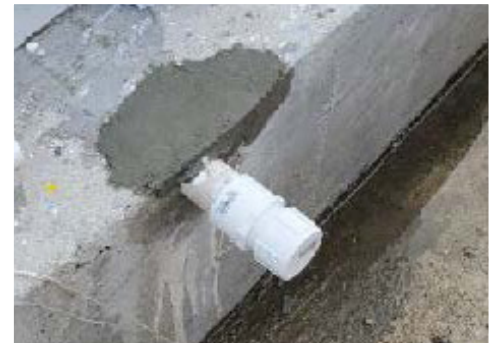
9. GROUT REPAIR

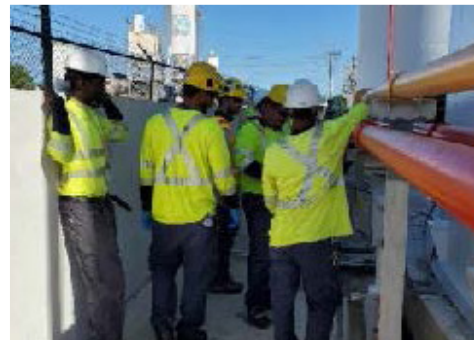
11. VCI SYSTEM TRAINING
