## Corrosion Protection for 2 Double Bottom Storage Tanks on Sand/Gravel by Underside Injection IDS

### Project Specifics

Installation Dates  
May 5-13, 2020

Location  
Minnesota, USA

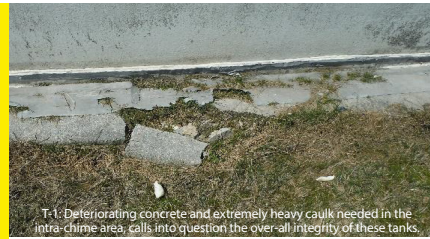
T-1: Deteriorating concrete and extremely heavy caulk needed in the intra-chime area, calls into question the over-all integrity of these tanks.

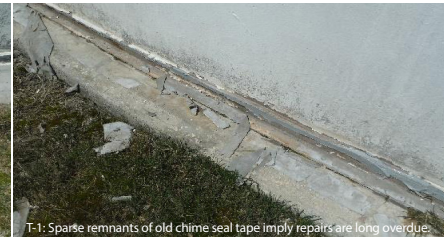
T-1: Sparse remnants of old chime seal tape imply repairs are long overdue.

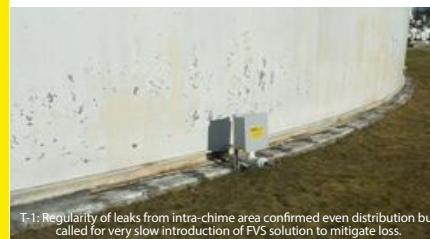
T-1: Regularity of leaks from intra-chime area confirmed even distribution but called for very slow introduction of FVS solution to mitigate loss.

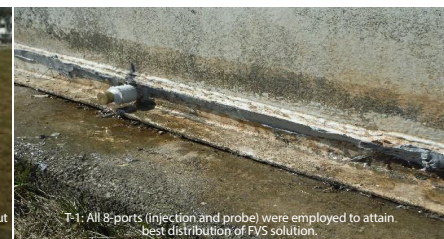
T-1: All 8-ports (injection and probe) were employed to attain best distribution of FVS solution.

Due to cold temps the sealant was given a day to cure while the team worked on preparation on Tank 2. Once sealant was cured, a strong mixture of the corrosion inhibitor solution was slowly pumped into all 8 available ports.

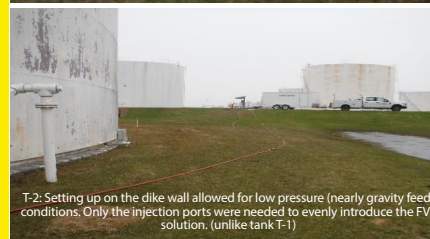
T-2: Setting up on the dike wall allowed for low pressure (nearly gravity feed) conditions. Only the injection ports were needed to evenly introduce the FVS solution. (unlike tank T-1)

Three useable ports were drilled and remaining unuseable were filled. The chime area was slightly better on Tank 13, a better caulk job was possible and no leaks other than about the probe pipes were observed. This allowed for using injection ports only for FVS introduction. As previously done, a near gravity-feed pressure was used at each injection port until FVS solution was observed coming out of near-by probe ports.

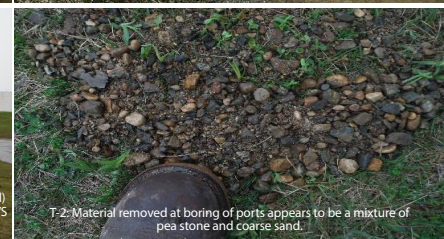
T-2: Material removed at boring of ports appears to be a mixture of pea stone and coarse sand.

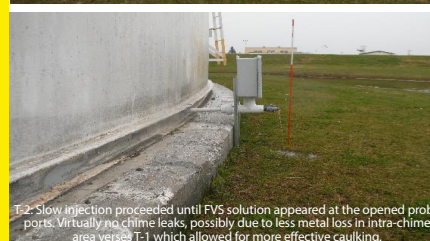
T-2: Slow injection proceeded until FVS solution appeared at the opened probe ports. Virtually no chime leaks, possibly due to less metal loss in intra-chime area versus T-1 which allowed for more effective caulking.

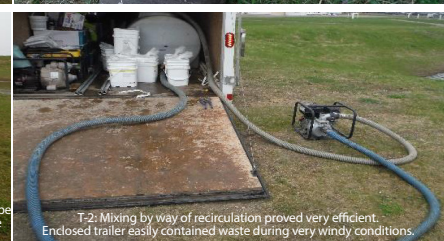
T-2: Mixing by way of recirculation proved very efficient. Enclosed trailer easily contained waste during very windy conditions.
