Corrosion Protection for 3 Single Bottom Storage Tanks on Sand Foundation via Internal Flood and Underside Injection

Project Specifics

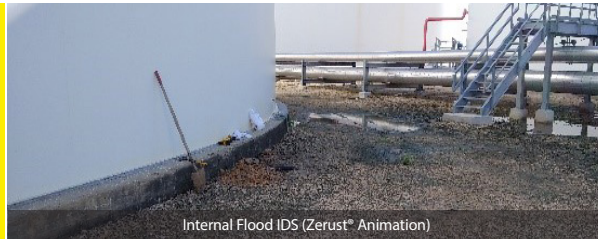
Internal Flood IDS (Zerust Animation)

Internal Flood IDS was used for this tank and since the tank was out-of-service, the corrosion inhibitor solution was injected through the tank floor. Eight ports were installed at this interface as well (Four injection and Four ER probe). Only three ER Probes were installed. All 150-gallons of corrosion inhibitor slurry was injected.

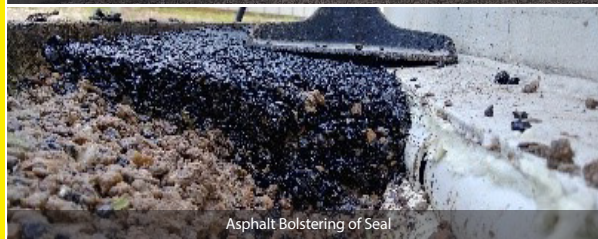
Asphalt Bolstering of Seal

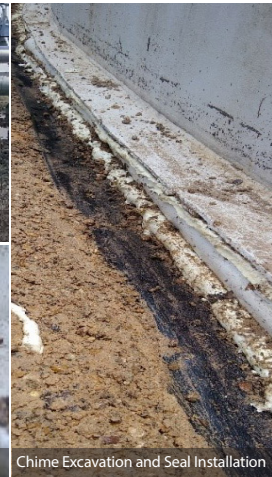
Chime Excavation and Seal Installation

The engineers at Zerust® Oil & Gas developed custom solutions for this client, and with the support of local contractors, successfully installed an IDS sealant system around the chime area of the targeted assets and completed the injection of the corrosion inhibiting solution slurry on the tanks using Zerust's Internal Flood IDS for Tank 1 and Underside Injection IDS for Tanks 2 and 3, along with the installation of ER probes for IDS monitoring.

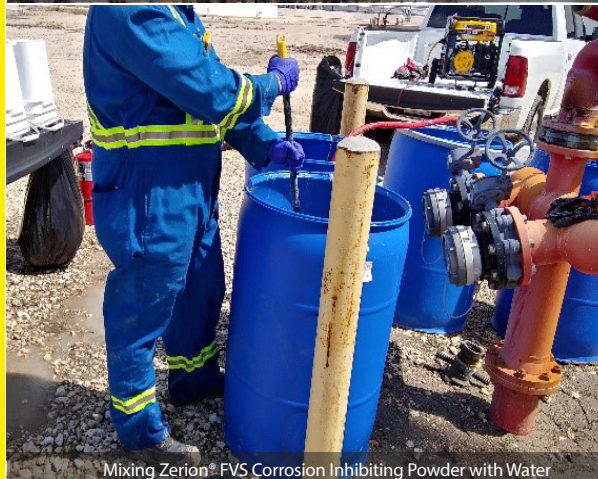
Mixing Zerion® FVS Corrosion Inhibiting Powder with Water

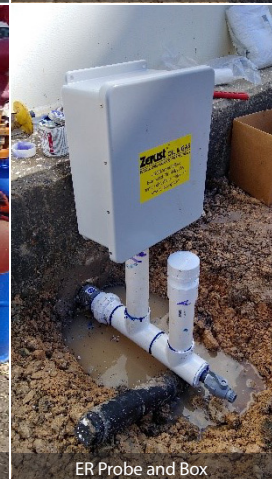
ER Probe and Box
