## Corrosion Protection for a Single Bottom Storage Tank on a Rocky Gravel Foundation via Internal Flood IDS

Asset Details  
Diameter: 143-ft  
Vessel Construction: Single-Bottom with a liner and without a Concrete Ring Wall.  
Foundation Media: Rocky/Gravel ~4 inch Depth

Inhibitor Delivery System (IDS)  
Internal Flood IDS with  
IDS Sealant & Monitoring Systems

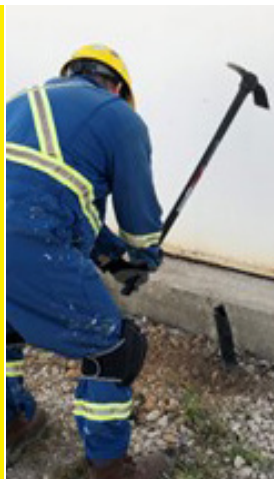
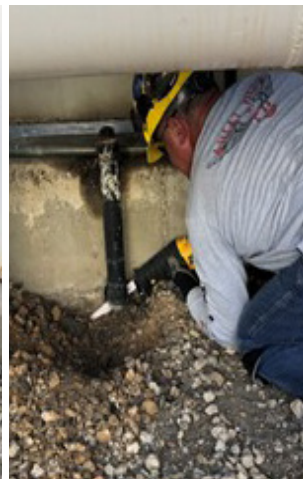
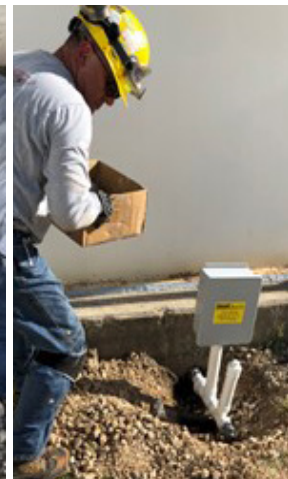
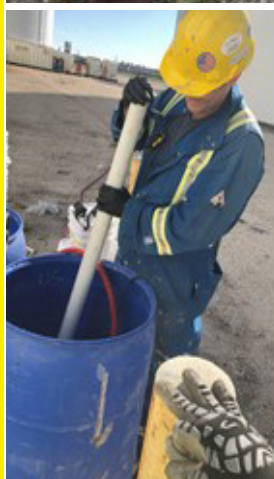
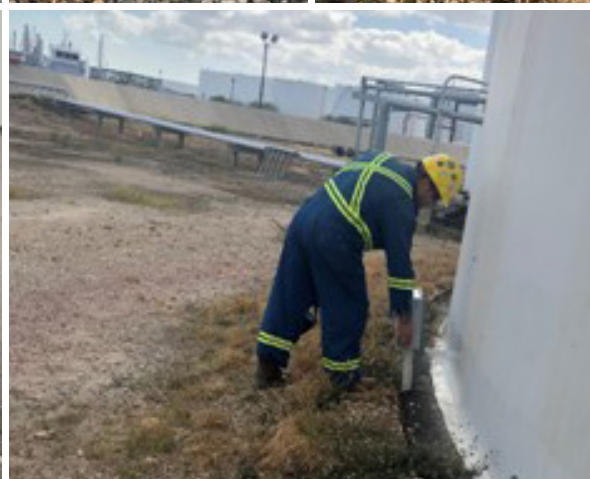
The team dug out small areas of gravel/clay around existing old ports, which were replaced by Zerust Electric Resistance (ER) Probe assembly port connection on all three (3) trench channels at a 90-degree incline. Wire brushing was performed on the

Sikaflex adhesive was applied on the circumference of the tank and sealed due to high gaps between the upper surface of the concrete area and the chime ring base area. PVC pipes were assembled and installed in ports through the (3) ring wall locations. Each port is connected to a trench that goes to the center of the tank foundation. Port assemblies were connected to the old ports which were cut and connected at the base of the trench wall for installation of ER probes. FVS Inhibitor was injected through the floor plate ports inside the tank using garden hose and submersible water pump. The application was continually done through all four (4) welded ports in the tank. Inhibitor injection was pumped/injected using a submerging pump and four (4) 100ft hoses connected through the entrance of the tank.
