Corrosion Protection of Five Buried Pipe Casings using Zerust's Zerion® FVS Powder, & PGH-300 & 400 Gels

Project Specifics

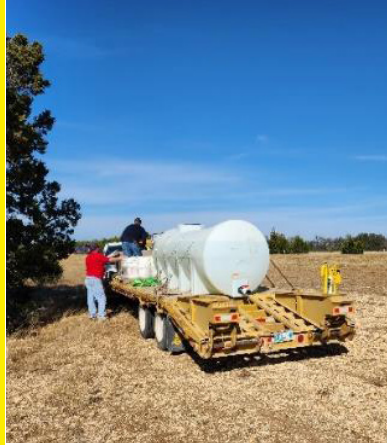
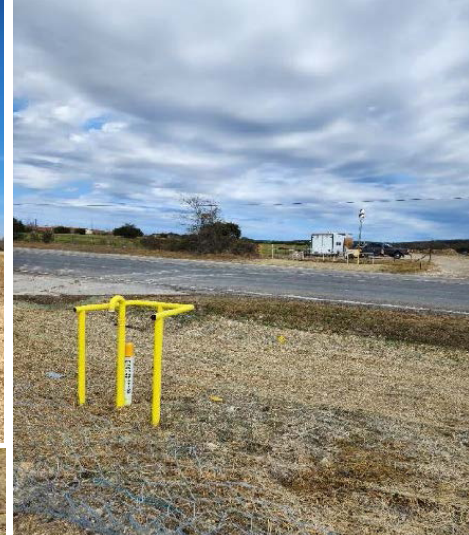
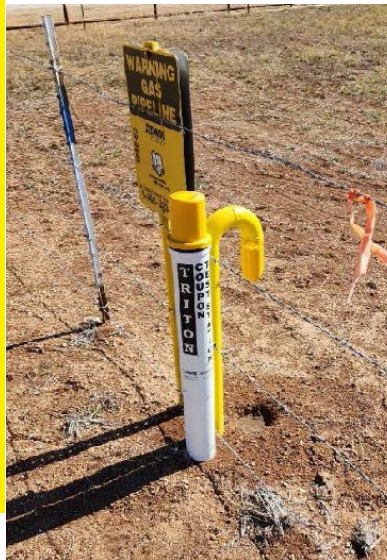
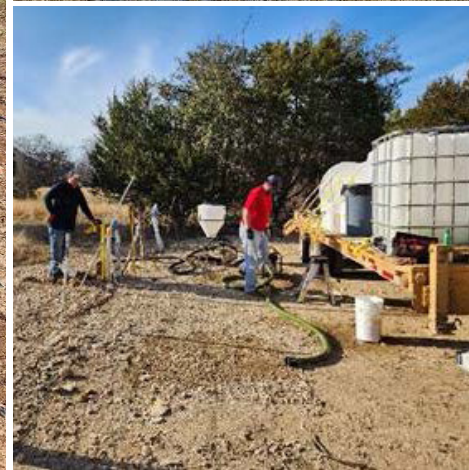
This project includes the application of a corrosion inhibitor solution (composed of a mixture of Zerion FVS corrosion inhibitor powder, Zerion PGH corrosion inhibitor gels and clean, potable water) into a total of five (5) pipe casings.

The ER probes were supplied by Zerust but the RMU equipment was to be supplied by the client. At the time of implementation of this project, the RMUs were not available, therefore the ER probes were not installed but were retained by the contractor. Following a visual inspection of each of the assets, the corrosion inhibitor solution was mixed and injected. The injections were able to be carried out under 5-PSI and for each asset, corrosion inhibitor solution was injected through one (1) vent pipe until solution was apparent on the opposite vent pipe.
