## Pipe Casing Injection for Corrosion Protection of Mechanically Shorted Cased Crossing

### Project Specifics

Pipe Casing Construction Details  
Casing Diameter: 20"  
Pipeline Diameter: 12"  
Length: 197'  
Mechanically Shorted

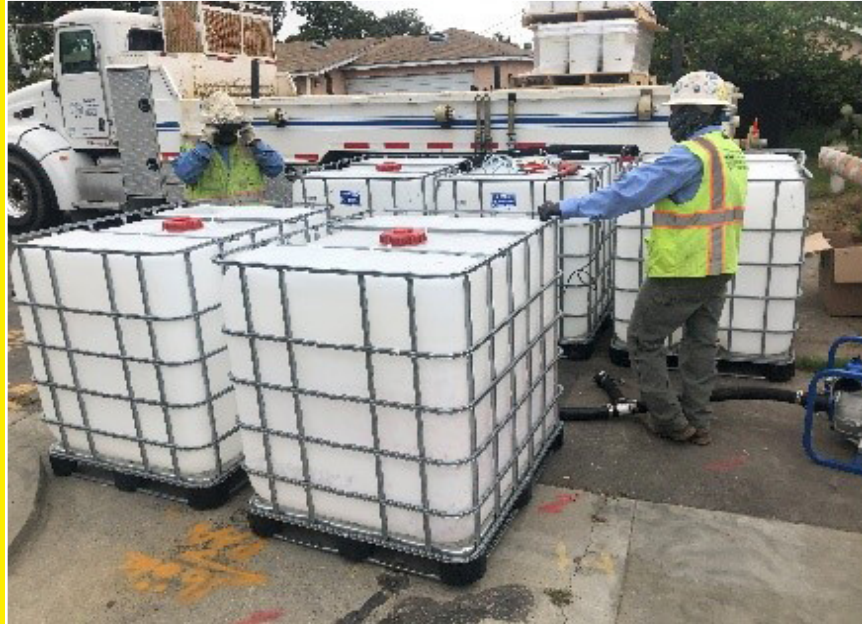
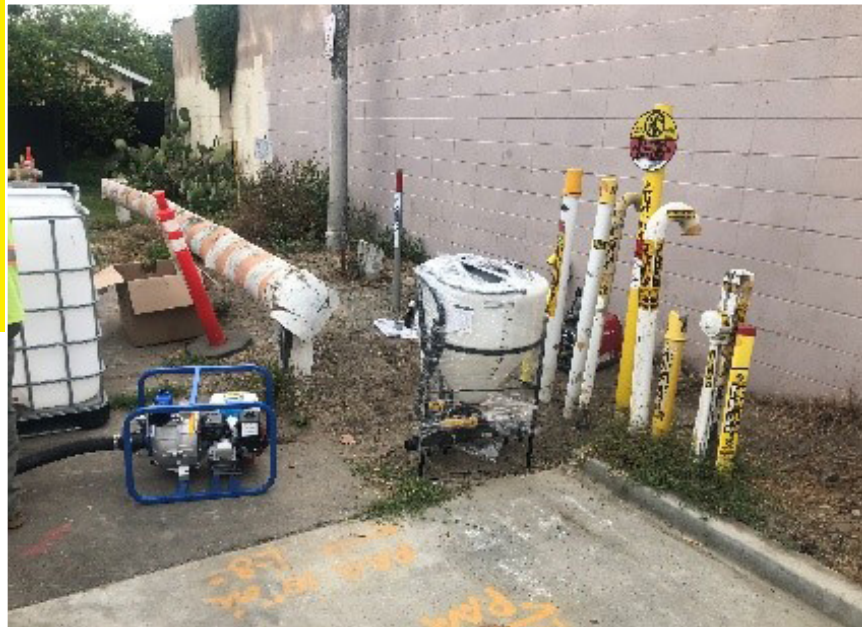
The vent pipe used for the injection had to be cut and threaded for the injection fittings. A threaded coupler was used to replace the cut section of the vent pipe to restore the "candy cane" like shape. The other vent pipe only needed a rubber coupler.

The injection went quite well. Every pail of PGH-400 and 80% of the PGH-300 was able to be added to the inhibitor slurry during the injection. A person stood watch over the opposite side of the casing to see if there was any discharge. None was reported. The slurry was injected into the low end of the slope.
