## Pipe Casing Injection for Corrosion Protection of Casing Crossing State Highway

### Project Specifics

Pipe Casing Construction Details  
Casing Diameter: 30"  
Pipeline Diameter: 24"  
Length: 88'

Zerust Product(s) Used  
Zerion<sup>®</sup> FVS Corrosion Inhibitor Powder  
Zerion<sup>®</sup> PGH-300 Corrosion Inhibitor Gel

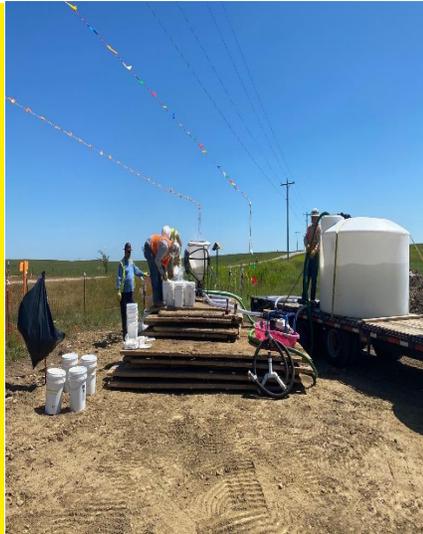
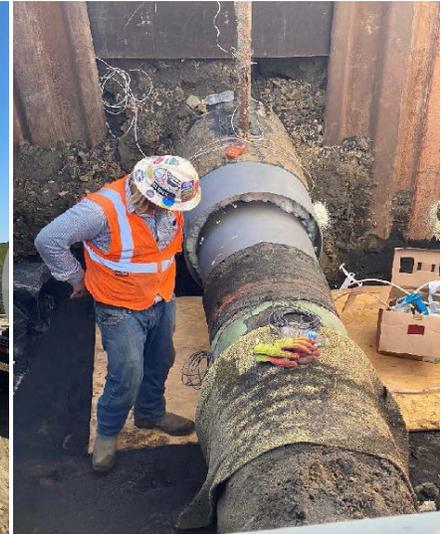
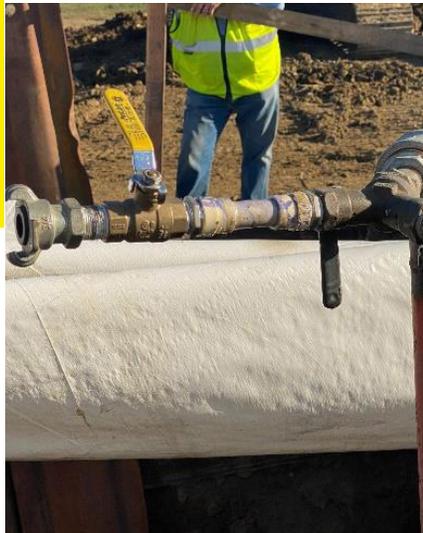
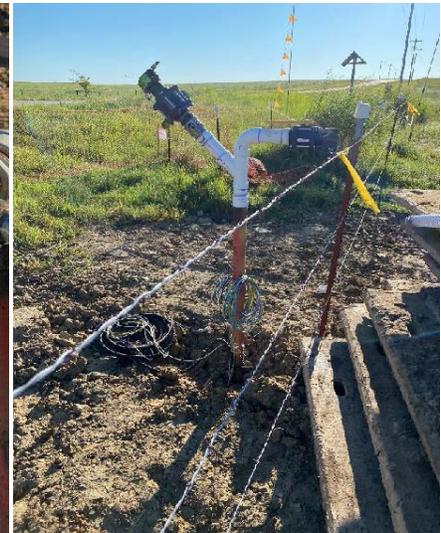
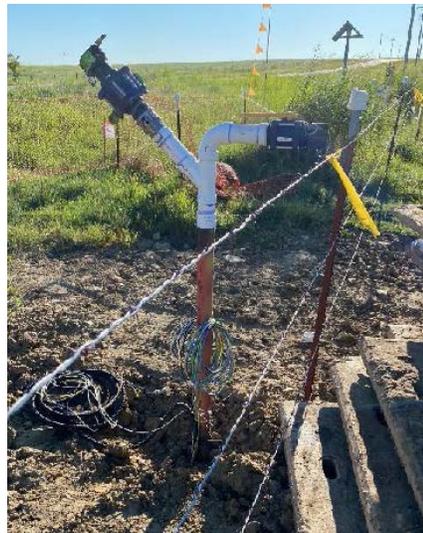
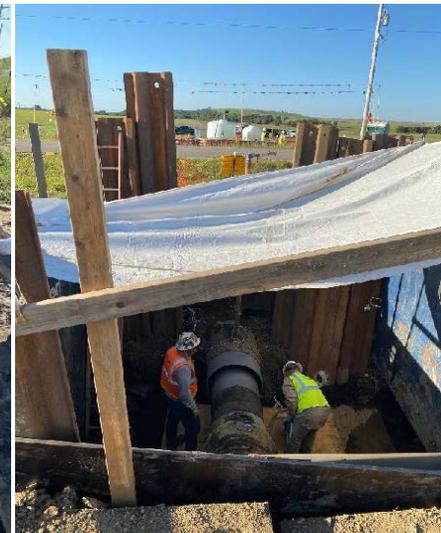
The 2" vent pipe used for the injection had to be fitted with Y-section bypass and air pressure relieve adapter. A threaded coupler with Banjo type fitting was used to connect eductor filling equipment.

The other 2" vent pipe only was used for monitoring and to purge the air from the casing during VCI/Gel injection. The injection went very well. FVS solution was mixed with water and a bit over half of those pails of PGH-300 was able to be added to the inhibitor slurry during the injection. It was necessary to bleed the air out of the casing that was trapped due to geometry of pipe line after injection. A small amount of FVS solution was lost due to this process. A person stood watch over the opposite side of the casing to see if there was any discharge. The discharge material was reported and injection of slurry was completed.

The pipe casing was filled up to 95% with roughly 750 gallons of VCI/Gel slurry and the project completed successfully.

The casing crosses a state highway. Both vent pipes were installed on the top of the casing. It should be noted that prior to the injection, the end seal was excavated and refitted with Handi Polyurethane foam and a Stopaq material and a 5 psi pressure test was completed. This excavated end was back filled and covered after VCI injection.
