Corrosion Protection of an Out-of-Service Crude Oil Tank on Sand Foundation by Underside Injection IDS

Project Specifics

Location
Angola, Africa

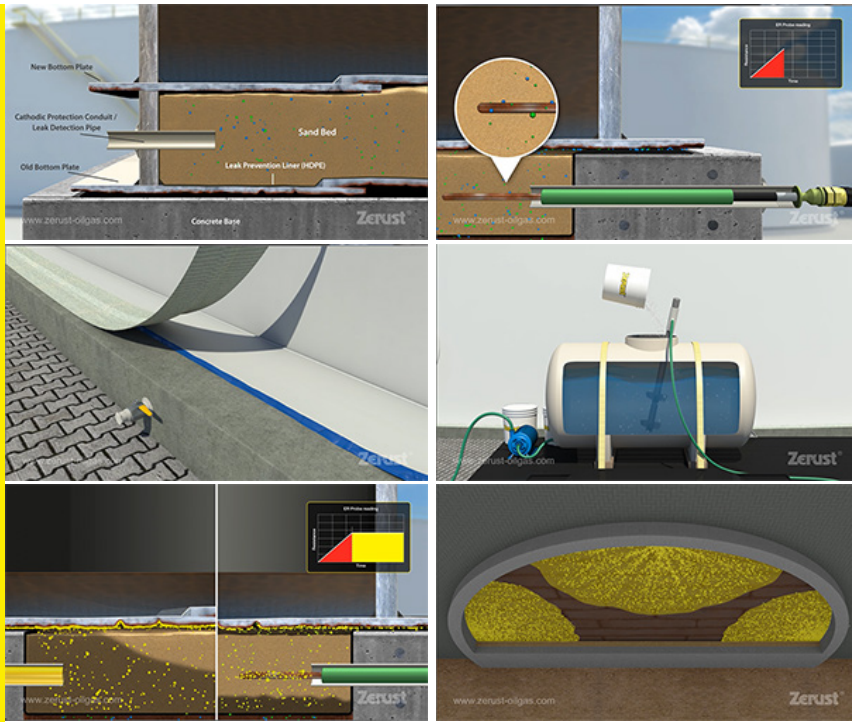
PICTURES SHOWN ABOVE ARE FROM ZERUST® ANIMATIONS. NOT FROM PROJECT REFERENCED IN DOCUMENT.

forty-two (42) leak detection ports) had been drilled beneath the original bottom and were previously fit with Electrical Resistance (ER) probes for baseline corrosion monitoring. The leak detection ports were installed with fittings for injection of a corrosion inhibitor slurry. Additionally, four (4) ports (in addition to the thirty-two (32) leak detection ports) had been drilled through the dead shell (beneath the new bottom) and were also fit with ER probes for baseline corrosion monitoring, with the leak detection ports installed with fittings for injection of a corrosion inhibitor slurry.

The engineers at Zerust® Oil & Gas developed a custom solution for this client using their Underside Injection IDS. Zerion® FVS and Zerion® FAN-5 Corrosion Inhibitor Slurry was injected between the new and old tank floors and ER Probes and Box were set up.
