Zerust® ReCAST - SSB

CORROSION MANAGEMENT FOR ABOVEGROUND STORAGE TANKS

PREVENTION OF SOIL SIDE BOTTOM CORROSION OF ABOVEGROUND STORAGE TANKS (ASTs)

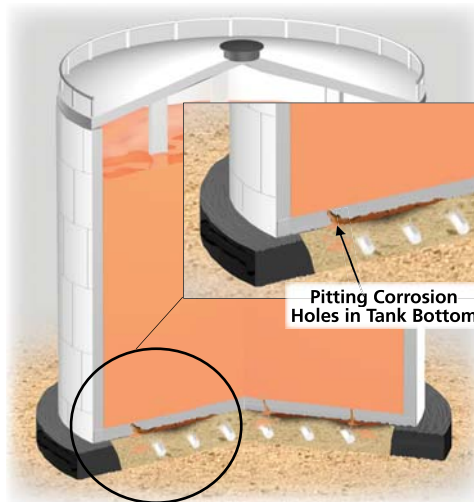
PROBLEM

Corrosion of Soil Side Bottoms (SSBs) of Above ground Storage Tanks (ASTs) causes the formation of holes that allows product leakage into the environment. This specific type of corrosion is called soil side pitting corrosion, and forms in the gaps or "vapor spaces" between the metal tank bottom and the soil/concrete slab it rests on. These "vapor spaces" are formed when the metal bottom flexes up and down when product is filled and removed from the AST. Traditional cathodic protection (CP) systems have proven to be ineffective in these situations because CP cannot function when vapor space gaps break the essential electro-chemical circuits formed by direct contact between the soil (electrolyte) and the metal tank bottoms. This problem can be further exacerbated by the use of bituminous beds below the tank bottoms. Acids from the surrounding soil will seep through the beds to directly attack the metal tank bottoms. Alternatively, in coastal areas, high ambient humidity and/or rainfall causes moisture to seep between and separate the metal bottoms and the bitumen (called "sweating"). This problem also manifests itself with double bottom constructions, when the sand bed between the two bottoms becomes saturated with water over time and causes corrosion of the soil side of the upper tank bottom.

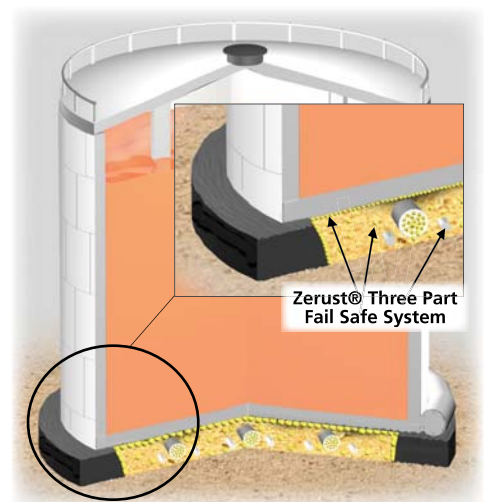
SOLUTION

Three Part Fail-Safe System: The client deployed NTIC's proprietary Zerust® ReCAST-SSB inhibitor in the sand bed between the two bottom layers. The inhibitors were implemented at the same time as the replacement of the bottom. The full system consists of three parts:

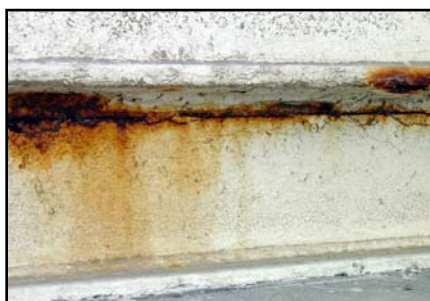
ACTUAL CLIENT SITE CORROSION: The sand bed between the two tank bottoms became saturated with water, causing significant pitting corrosion in the upper tank bottom.

CORROSION DAMAGE ON THE UPPER BOTTOM PLATES OF THE ABOVEGROUND STORAGE TANK

COST IMPACT OF ACID GAS CORROSION: The pattern of rust indicated that pitting corrosion had either eaten through, or considerably weakened, the bottom plate meaning that patchwork repairs would be insufficient and that the entire bottom had to be replaced.

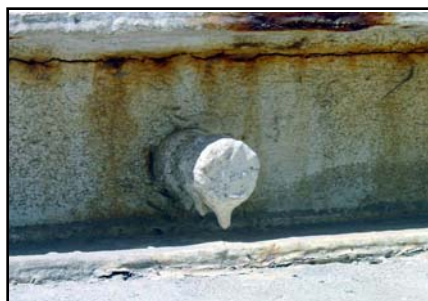
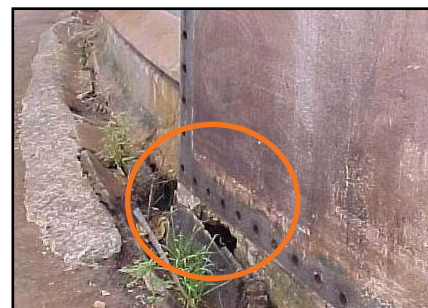
CORROSION HOLES IN THE AST BOTTOM

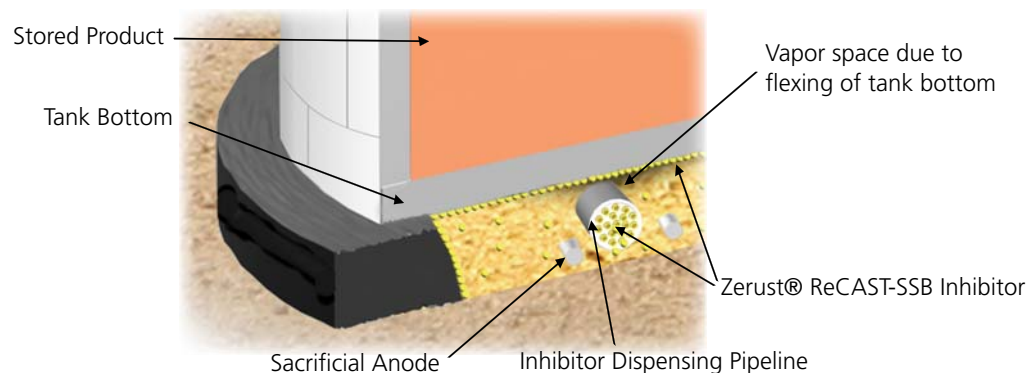
The full three-part system allows for inhibitor concentrations to be adjusted through a tank bottom inhibitor delivery system with a delivery station that is installed outside the tank base. This is critical to maintain the efficiency of corrosion mitigation throughout the life of the tank. NTIC periodically monitors the effectiveness of this solution by analyzing the data emitted from sensors implanted in the tank bed. NTIC also employs other measurement techniques that do not require stoppage of tank operations. Through this combination of technique and technology the NTIC team is able to adjust the system characteristics as required to minimize corrosion.

Cathodic Protection System: This system is required to protect the tank bottoms when the sand becomes saturated with water that comes into contact with the metal surfaces.

Vapor Corrosion Inhibitors (VCI): This component is required to protect the metal surfaces when there are vapor spaces (e.g. due to uneven flexing of the tank bottom, depressions in the sand layer, etc.).

Soluble Corrosion Inhibitors: These compounds are required to protect the metal surfaces when in contact with water – and they work in conjunction with the Cathodic Protection system to reduce the overall current density required (lower costs).
