Zerust Provides Corrosion Protection for Tank Bottom using Underside Drip Tube

Tank SSB IDS Underside Drip Tube

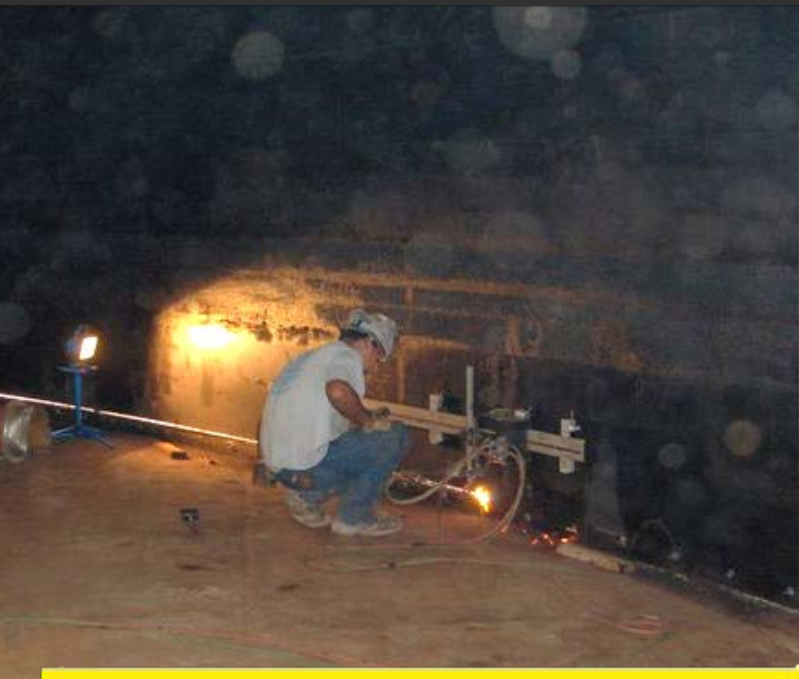
- Large oil terminal management client; double bottom tank with sand and liner
- Bottom plates are removed, slots are cut and tank is readied for the Zerust installation
- Perforated pipes are installed on the HDPE liner; ER probes are positioned on the base as well
- Large oil terminal management client; double bottom tank with sand and liner
- Bottom plates are removed, slots are cut and tank is readied for the Zerust installation
- Perforated pipes are installed on the HDPE liner; ER probes are positioned on the base as well

Client data for the past 12 months indicates an average SSB corrosion rate of ~1.87 mils/year (0.04mm/yr)
