## Corrosion Protection for an In-Service Gasoline Storage Tank with Liner on Sand/Soil Foundation by Underside Injection

### Project Specifics

Details  
Vessel Diameters: 50 Feet  
Storage Product: Gasoline  
Vessel Construction: In-Service, (5) Leak Detection Ports, HDPE Liner or Equivalent, Existing Chime Seal, Dike  
Foundation Details: Sand/Soil - Saturated

Inhibitor Delivery System (IDS)  
Underside Injection IDS with ER Probe Monitoring System

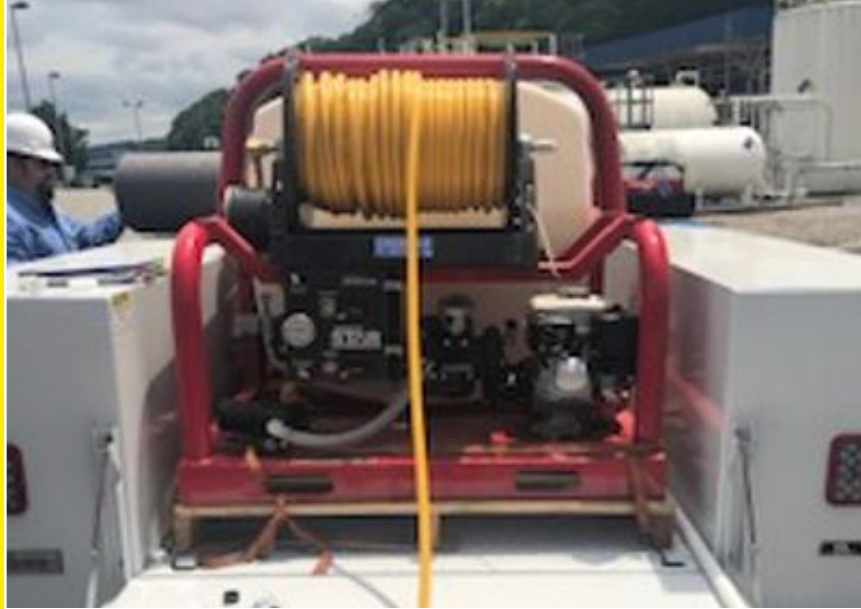
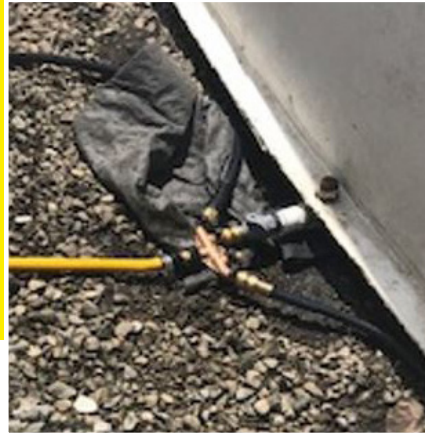
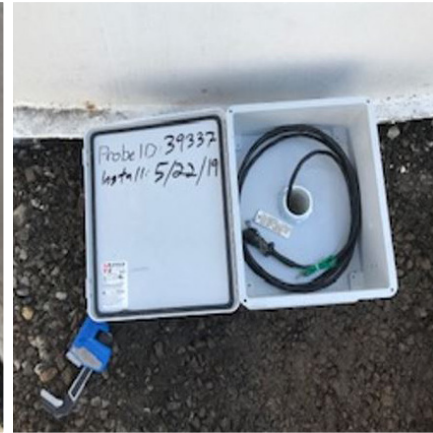
Injection was completed using three of the four available leak detection ports. Zerion FVS corrosion inhibitor were mixed with water for the injection process.

During the injection, minor leaks were observed coming from the gap between the new floor and the old shell. All leaks were contained using spill socks, and decrease of pumping pressure as necessary.

Injection was not done on the fourth port due to its proximity to an open CP port.

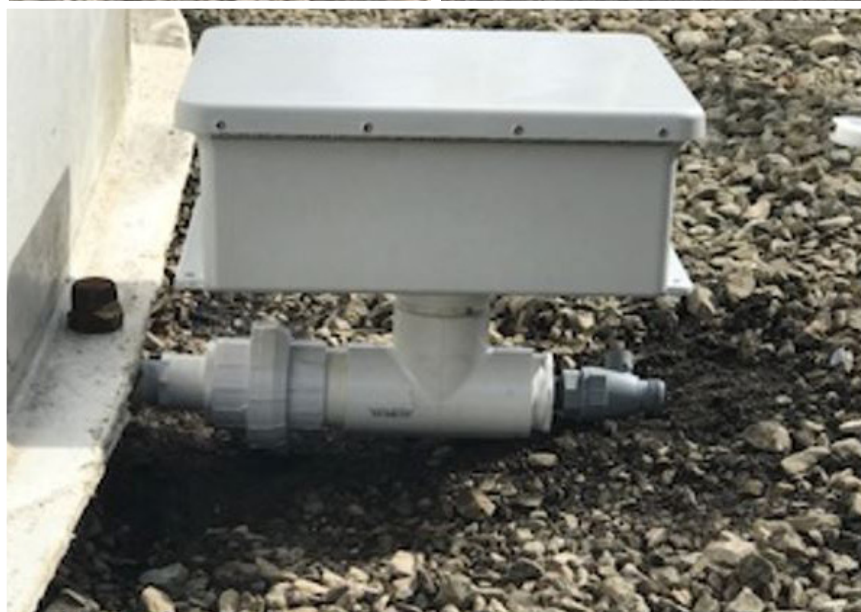
Electrical Resistance (ER) probes were installed the next day in two of the ports. Port A and port B were confirmed functioning as normal.
