Pipeline Preservation for the Corrosion Protection of Out-of-Service Pipelines

Project Specifics

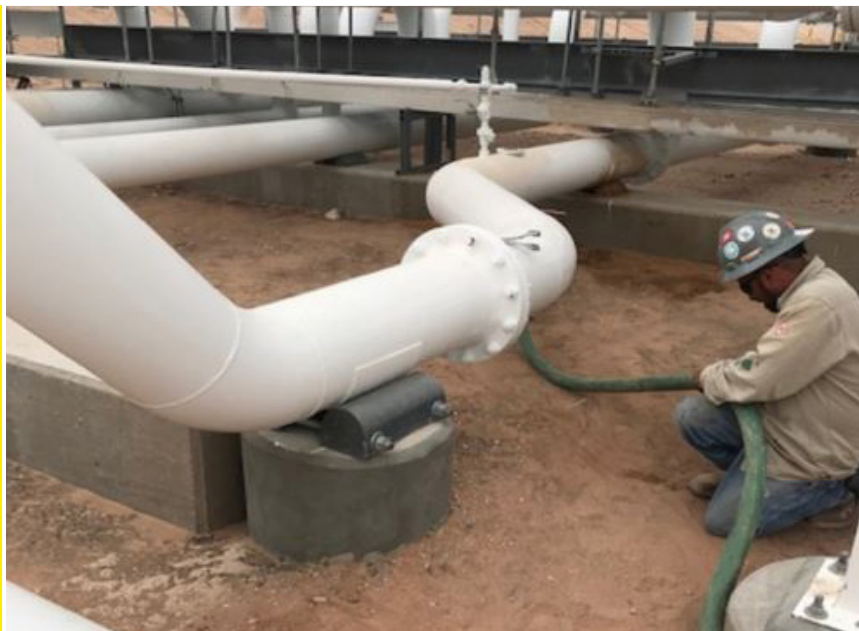
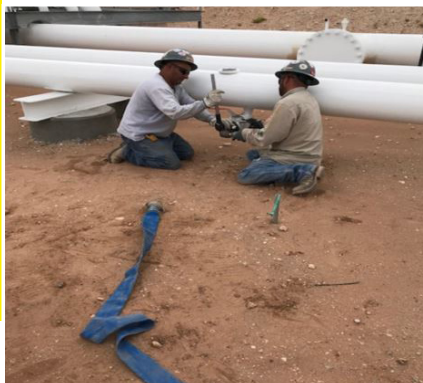
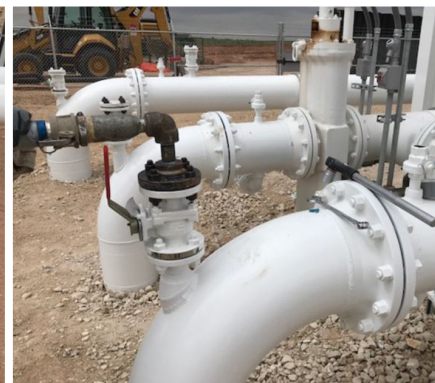
Project Installation Overview

Injection of the corrosion inhibitor compounds was initiated and completed.

The corrosion inhibitor solution mixture of FVS and FAN-5 were split equally between two large tanks filled with potable water and slowly mixed into the tanks until dissolved completely.

About 93.75% of this corrosion inhibiting solution mixture was injected into Pipeline "A" (12" dia.) at three separate locations, and the remaining ~6.25% was injected into Pipeline "B" (6" dia.). There were a total of 3 injection points along the 12" line, and a single injection along the 6" line.

The 12" line received ~68.75% of the solution mixture at injection point 1 (high side inside the terminal), ~6.25% of the solution mixture at point 2 (high side inside the terminal but short ~20-ft section), and ~18.75% of the solution mixture at point 3 (outside of main terminal fence). The 6" line received ~6.25% of the solution mixture at a single high side injection point outside of the main terminal fence. All injections were completed successfully.
