Pipe Casing Injection for Corrosion Protection of Pipeline in Florida

Project Specifics

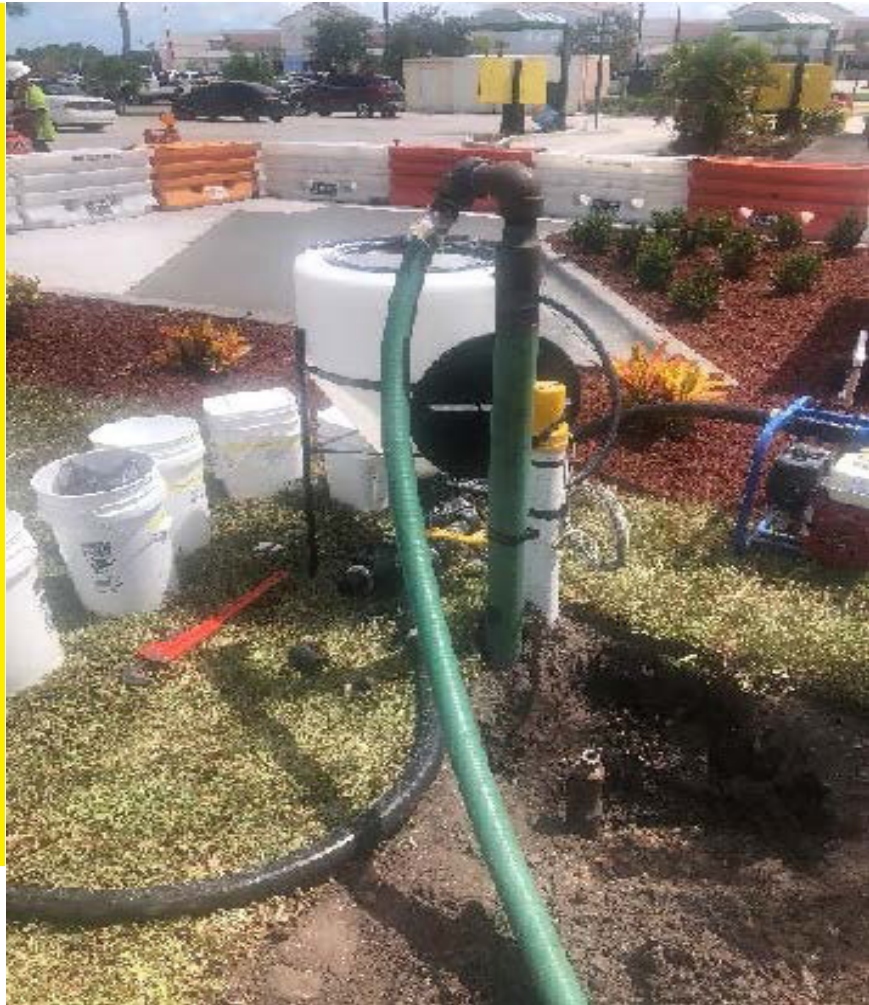
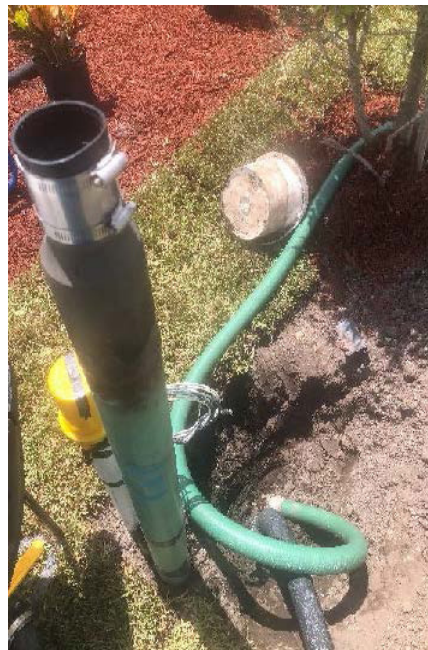
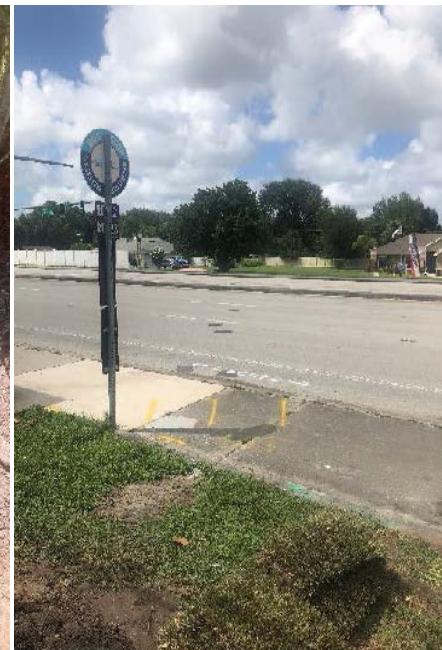
Both the bottom and top vents were in the same place. See provided photos. The casing extends to the middle of the road, so a vent could not be placed there.

Because the vents were so close to each other, we had to adjust the injection techniques. We would inject the slurry until we saw gel coming out of the other vent. We would shut the pump off and let the slurry even out in the casing. We repeated this step multiple times. This maintained a minimal loss of slurry.

The noted quantities of corrosion inhibitors were applied with no issue and the project successfully completed.
