Pipe Casing Injection for Corrosion Protection of 6 Casings using Zerion[®] FVS Corrosion Inhibitor Powder & Gel

Project Specifics

Pipe Casing Construction Details (All 6 Casings)
Casing Diameter: 42"
Pump Barrel: 36"
Length: 42'

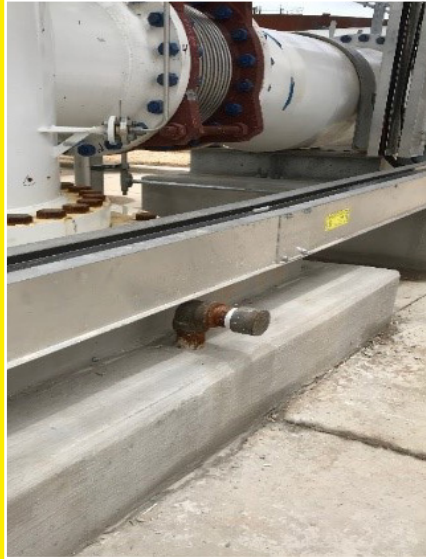
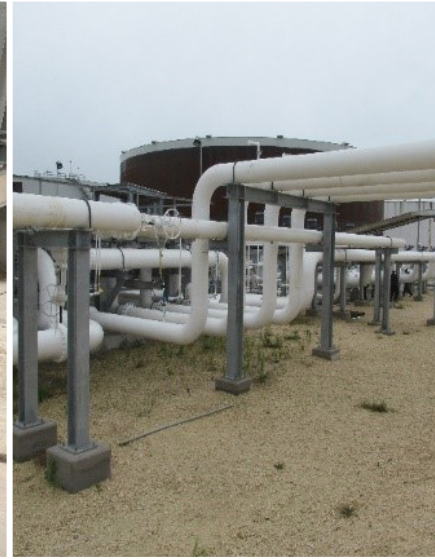
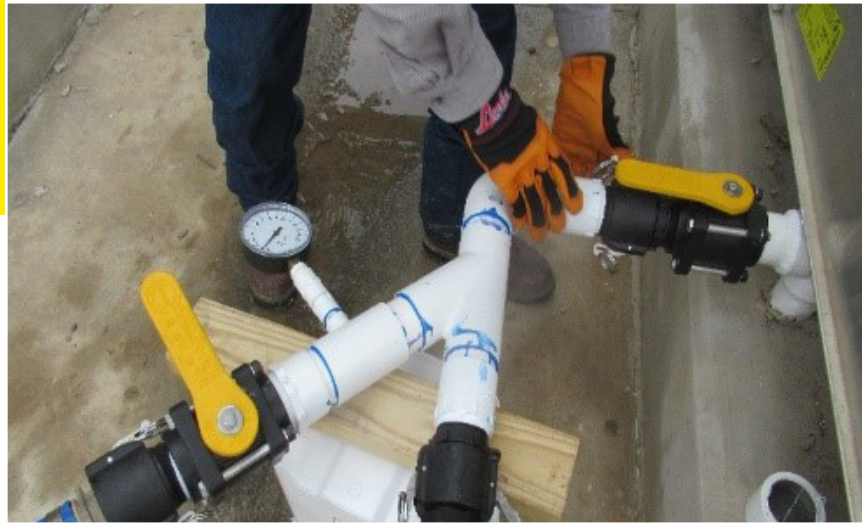
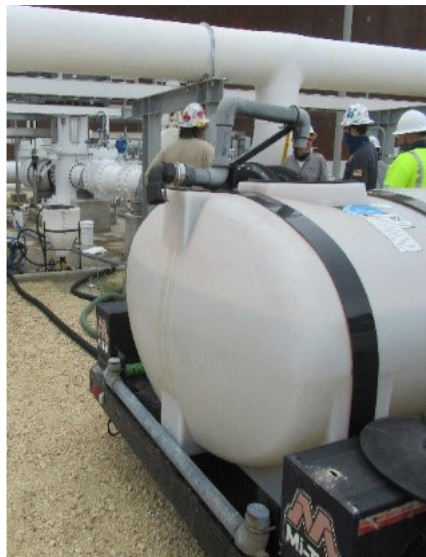
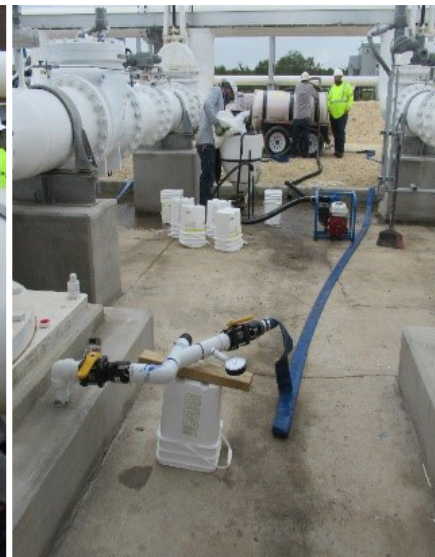
The 2" vent pipe used for the injection had to be fitted with Y-section bypass and air pressure relieve adapter. A threaded coupler with Banjo type fitting was used to connect eductor filling equipment. The other 2" vent pipe only was used for monitoring and to purge the air from the casing during VCI/Gel injection.

The injection went very well. FVS solution was mixed with water; PGH-300 was added to the inhibitor slurry during the injection. A person stood watch over the opposite side of the pump to see if there was any discharge. The discharge material was not reported and injection of slurry was completed. Each pump casings was filled up to 85% with VCI/Gel slurry.
