Corrosion Protection for a Single Bottom Storage Tank on Concrete Foundation via Chime Ring Dry and Dry Tube IDS and Dry Tube IDS

Project Specifics

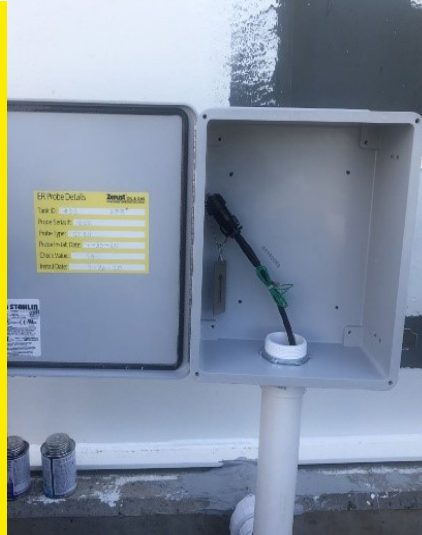
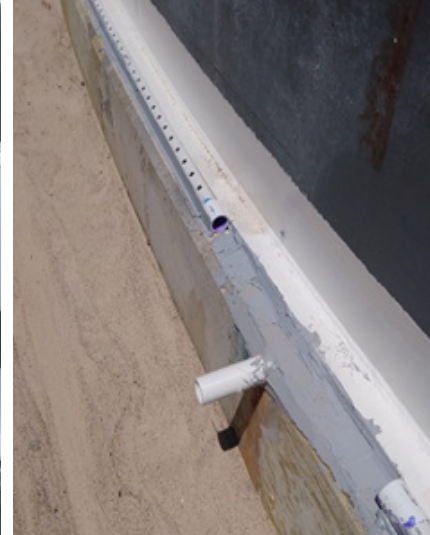
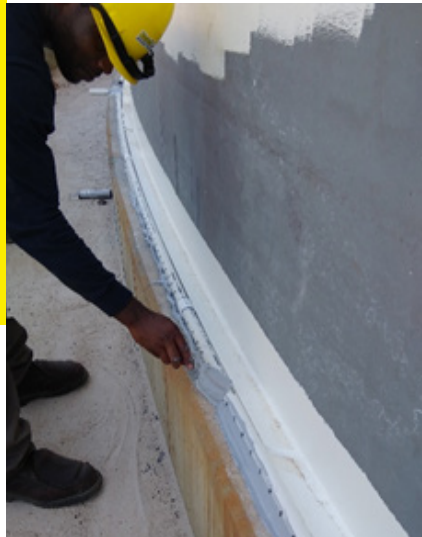
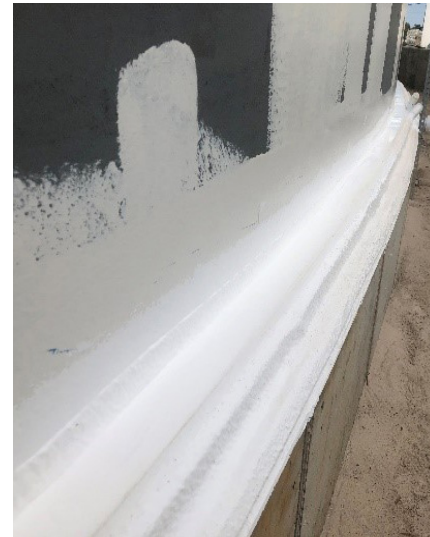
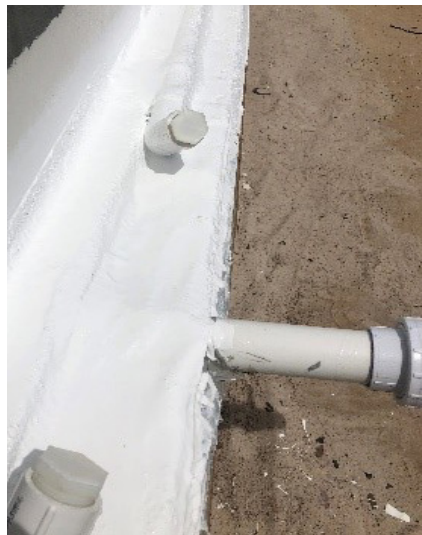
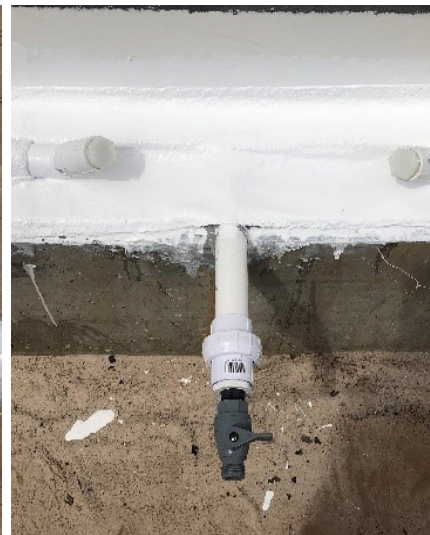
PVC pipes were installed in ports through the ring wall at fourteen (14) different locations. Each port is connected to a trench that goes to the center of the tank foundation. Ports assemblies were connected to the installed PVC pipes that will allow for a helium test to be conducted. A union was used in the connection so the PVC pipes would remain accessible for the installation of the sleeves. An additional four (4) ports were used to install the ER probes listed above. ER probe readings were taken from each installed unit and analysis shall be provided in proceeding reports upon gathering of further data. All eighteen (18) pipes were bonded to the trench using Sikaflex polyurethane construction adhesive.

Chime Ring IDS PVC pipes were installed around the tank circumference at the chime/tank floor plate interface and each was bonded to the concrete with Sikaflex polyurethane construction adhesive. Chime Ring IDS PVC ports were installed at each Dry Tube IDS port
